Environmental Projects: Volume 12

Friable Asbestos Abatement, GDSCC

Goldstone Deep Space Communications Complex

The present report, which describes the friable asbestos-abatement program at the GDSCC, consists of the text, illustrations, and tables that describe the friable asbestos abatement carried out at the GDSCC from December 21, 1988, to its end on May 11, 1989. All records and archival material pertinent to the implementation of the friable asbestos-abatement program can be found in Friable Asbestos Abatement Supplemental Records, JPL D-7450 (internal document), Jet Propulsion Laboratory, Pasadena, California.

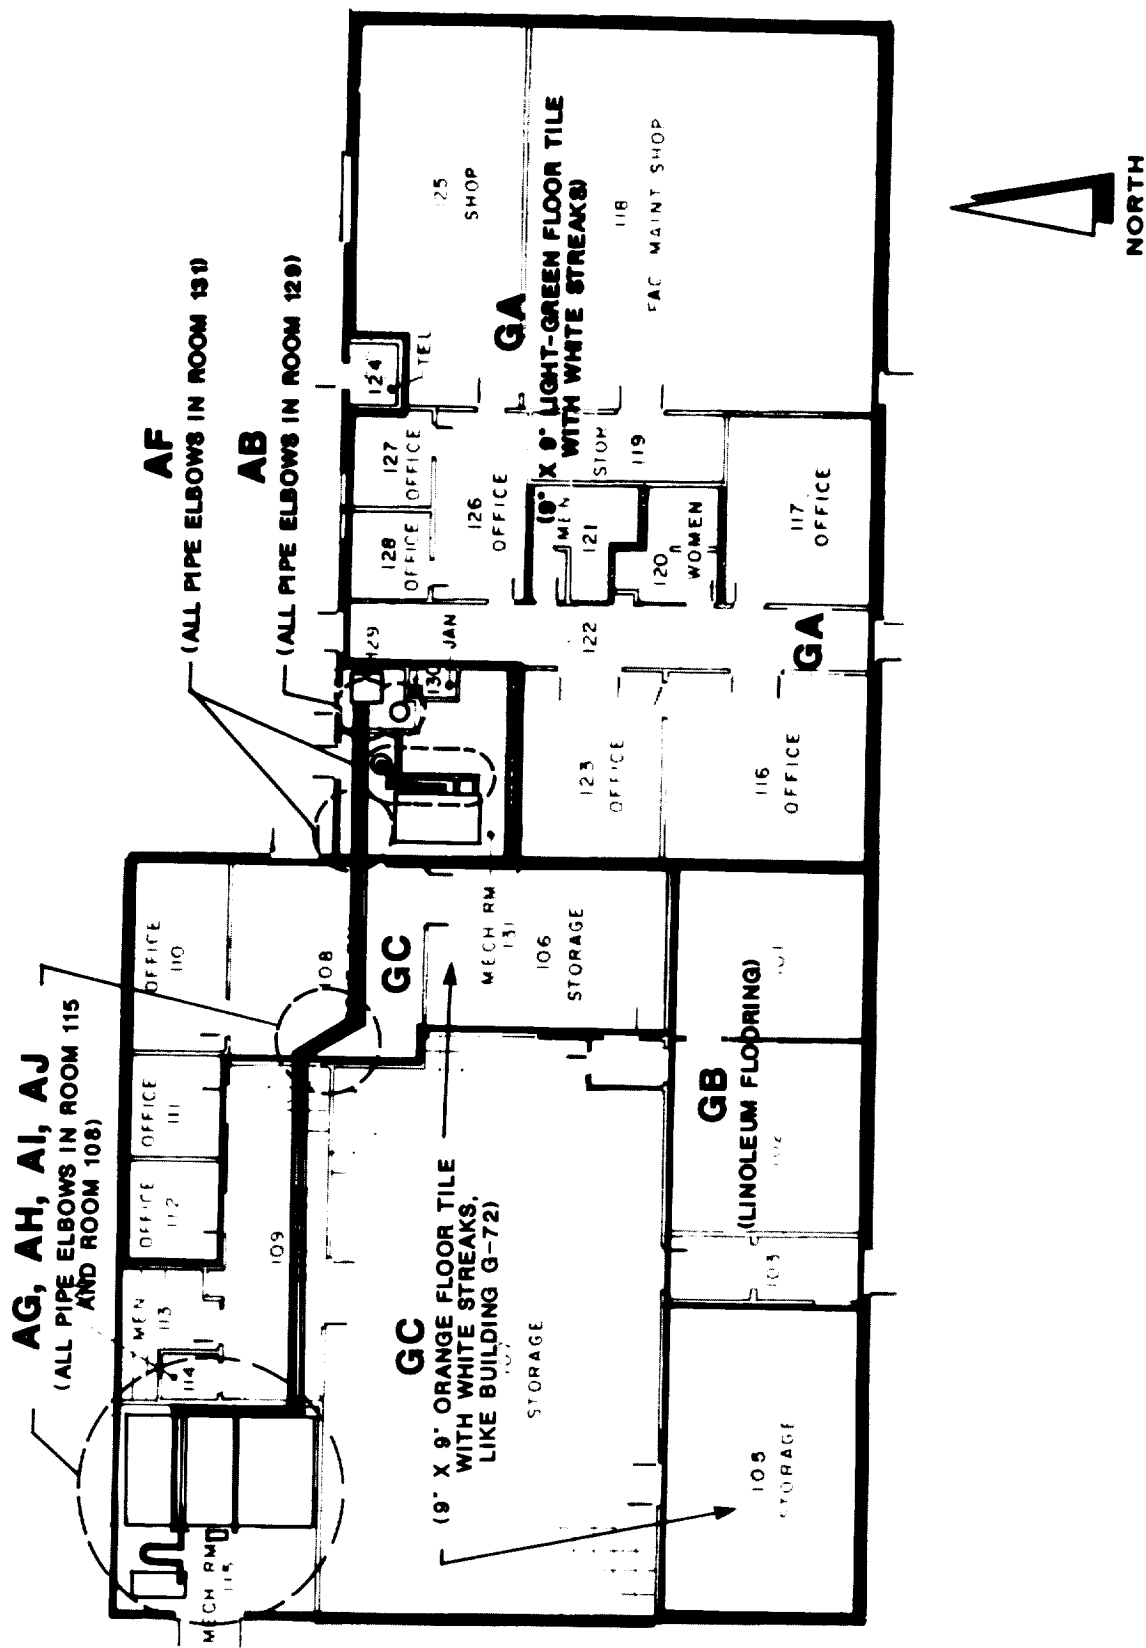
e. Building G-38 (Figures 18 and 19)

Comments: ELBOW MATERIAL HARD CEMENTITIOUS. SEE FIGURE 18.

Comments: HARD CEMENTITIOUS MATERIAL USED ON ELBOWS. SEE FIGURE 18.

Comments: HARD CEMENTITIOUS ELBOW LAGGING. TOTAL OF 9 ELBOWS IN ROOM. SEE FIGURE 18.

Comments: HARD CEMENTITIOUS MATERIAL ON PIPING ELBOW. SEE FIGURE 18.

Comments: HARD CEMENTITIOUS MATERIAL ON PIPING ELBOW. TOTAL OF 7 ELBOWS IN ROOM. SEE FIGURE 18.

Comments: HARD CEMENTITIOUS MATERIAL ON PIPING ELBOW. TOTAL OF 4 ELBOWS IN ROOM. SEE FIGURE 18.

Comments: LINOLEUM SHEETING. SEE FIGURE 18.

Figure 18. Echo Site: Network Laboratory and Maintenance Facility Building G-38.

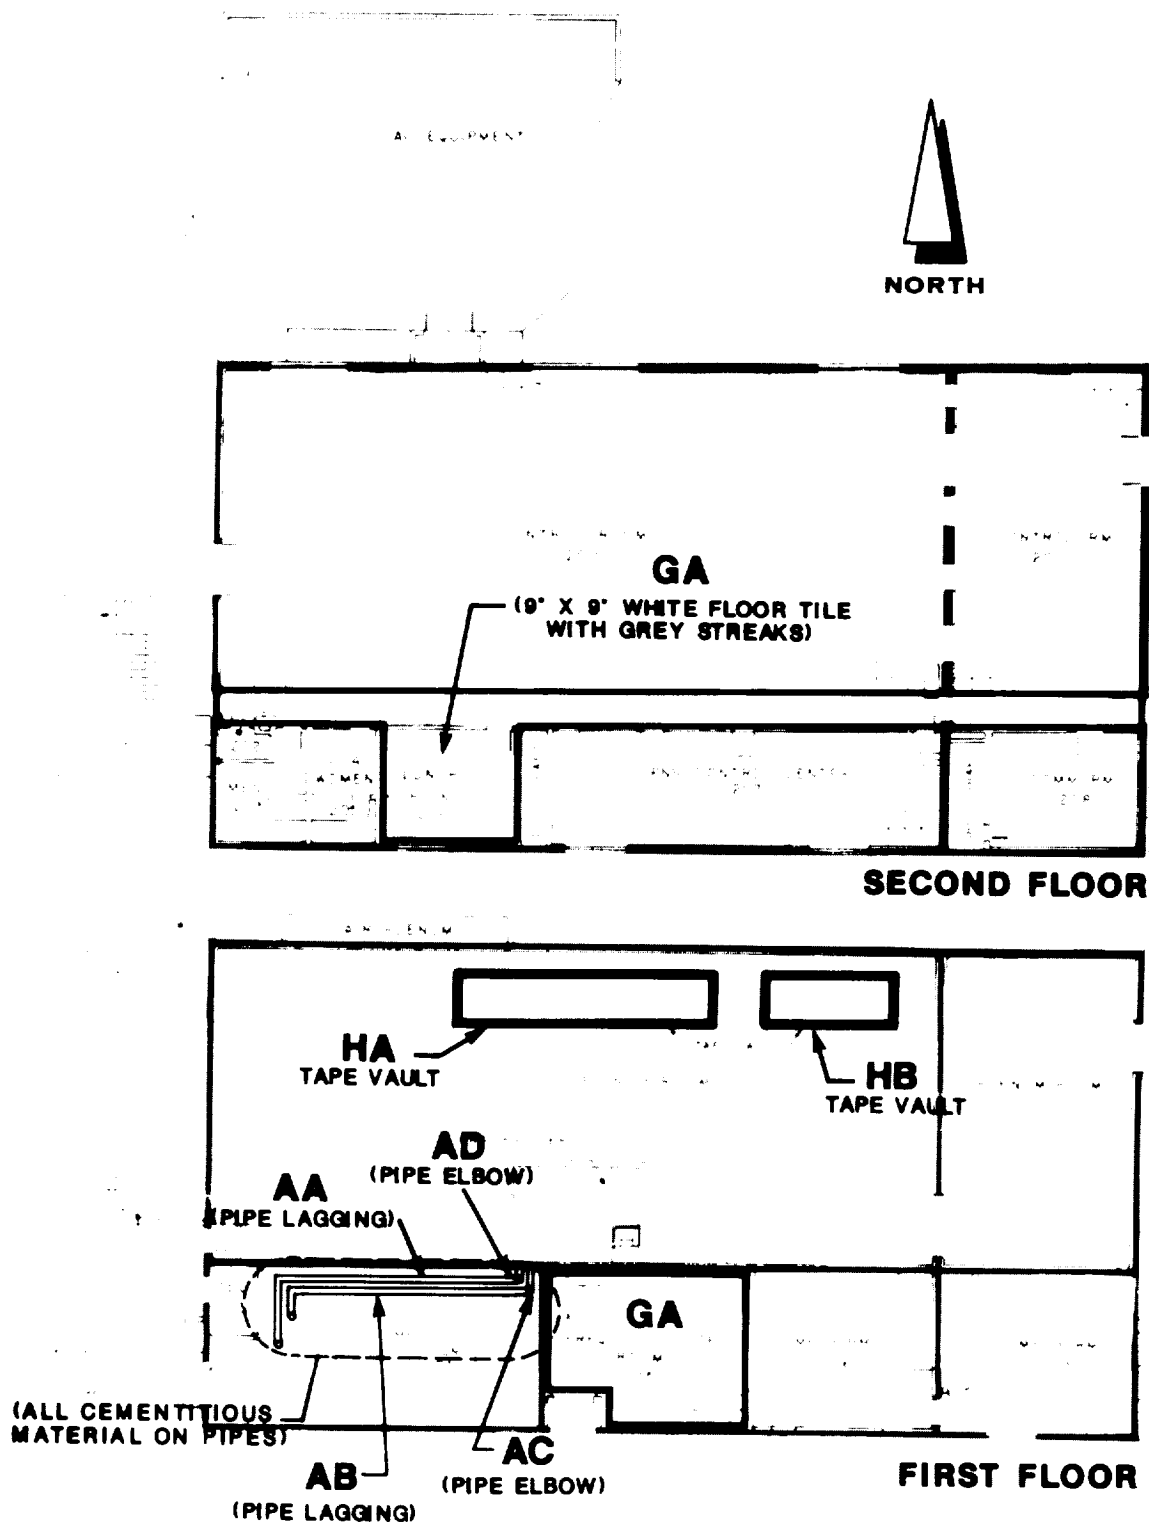
Building G-86 (Figures 31 and 32)

Comments: STRAIGHT PIPE LAGGING HARD CEMENTITIOUS MATERIAL. SEE
FIGURE 31.

Comments: STRAIGHT PIPE LAGGING HAS HARD CEMENTITIOUS MATERIAL.
SEE FIGURE 31.

Comments: ELBOW HARD CEMENTITIOUS MATERIAL. SEE FIGURE 31.

Comments: ELBOW HAS HARD CEMENTITIOUS MATERIAL. SEE FIGURE 31.

Comments: TAPE VAULT WALLS ARE IN GOOD CONDITION. MAINTAIN A GOOD PROTECTIVE COATING ON WALLS. SEE FIGURE 31.

Comments: 9 X 9 in. WHITE TILE WITH GRAY STREAKS. SEE FIGURE 31.

Figure 31. Mars Site: Operations Support Building G-86.

Pipes and pipe fittings insulated with friable asbestos in Room 104, the Mechanical Equipment Room, had their insulation removed and replaced with non-asbestos containing insulation. Because of its physical separation and isolation by walls, and its easy access from the outside, Room 104 had its friable asbestos-containing insulation removed and replaced without affecting the health and safety of the building's personnel.

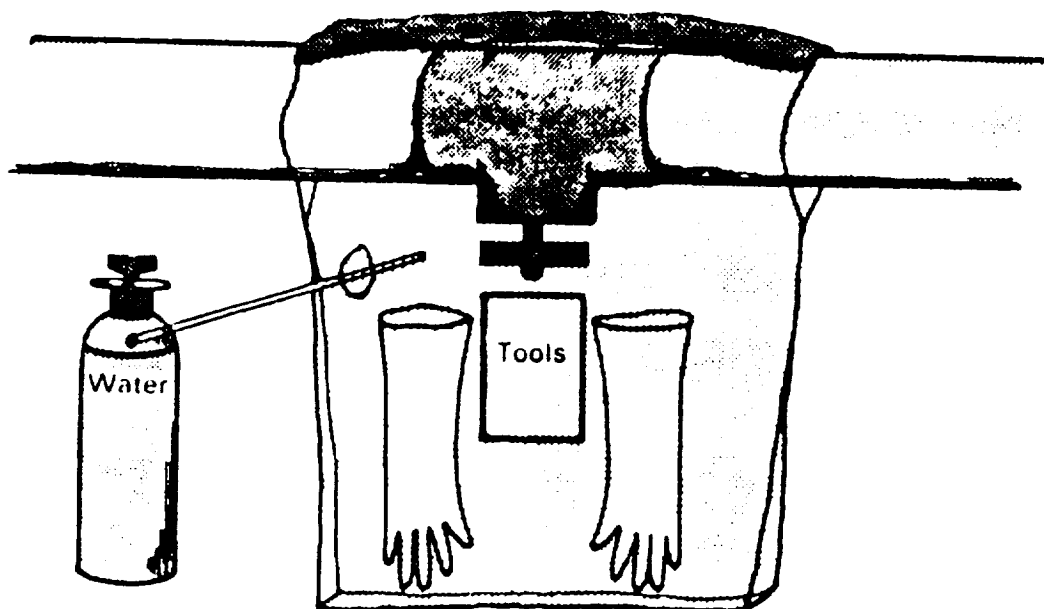
Figure 40. Illustration of "Glove Bag" Apparatus used in the Removal of Small Areas of Asbestos.

As with the removal of friable asbestos from the interiors of the 10 building/structures, the removal of the friable asbestos insulation from the three exterior pipes, mentioned in Section VI, G, was accomplished using the glove-bag technique (Figure 40). At Building G-22, the Fire Line Pump House, the exterior pipe (see Figure 39) first was surrounded by a mini-enclosure unit before the glove-bag removal technique was used.

To remove smaller quantities of pipe insulation, typical of conditions at the GDSCC, containment "glove bags" with sealed holes for hand access are alternatives to full-room or full-work area containment. As shown in Figure 40, these bags are positioned around the pipe insulation and sealed to the pipe with tape. Armholes and an inside pouch for tools let the worker remove insulation without exposure to asbestos fibers. A sealed side port can also be constructed to allow access for wetting the asbestos and evacuating the bag with a HEPA-filtered vacuum. Glove bags are available commercially.
